2007 Cocolalla Lake Association Eurasian Watermilfoil Project **Final Report**

Background

EWM Treatment

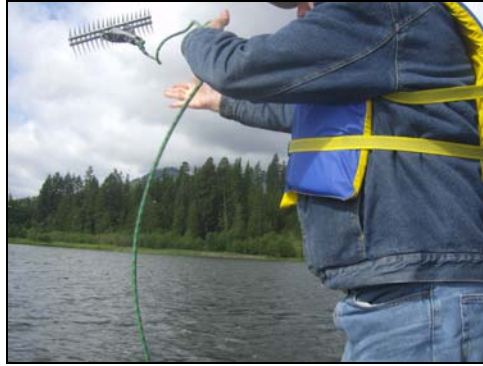
A pre-treatment EWM survey was conducted by ISDA on June 11 and 12, 2007. This survey was conducted using the rake-toss method. Results of this survey are depicted in Figure 1.

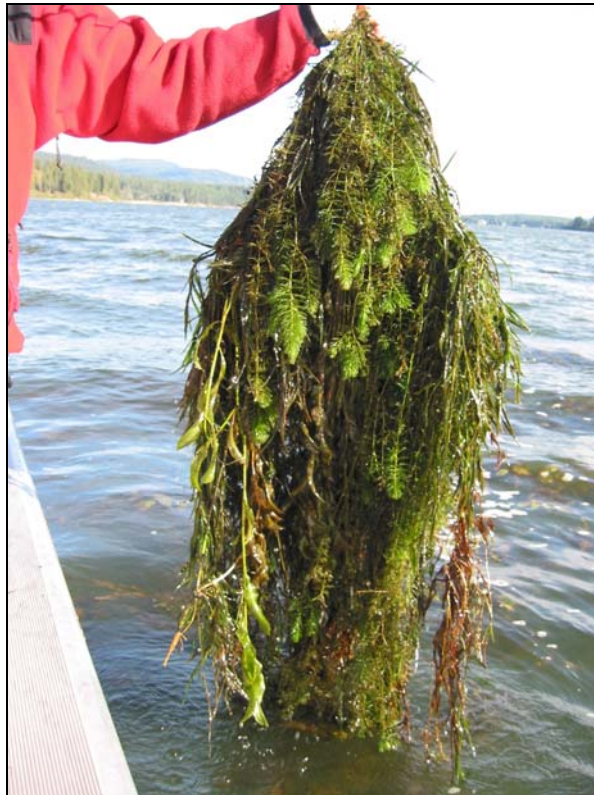
Post-treatment EWM survey was conducted by ISDA on September 19, 2007, again using the rake-toss method. Appreciable samples of native aquatic plants were found, with no apparent negative effects from the treatments. The results of the survey are shown in Figure 2.

No EWM was detected during the post-treatment survey, and none has been seen during visual inspection by CLA members.

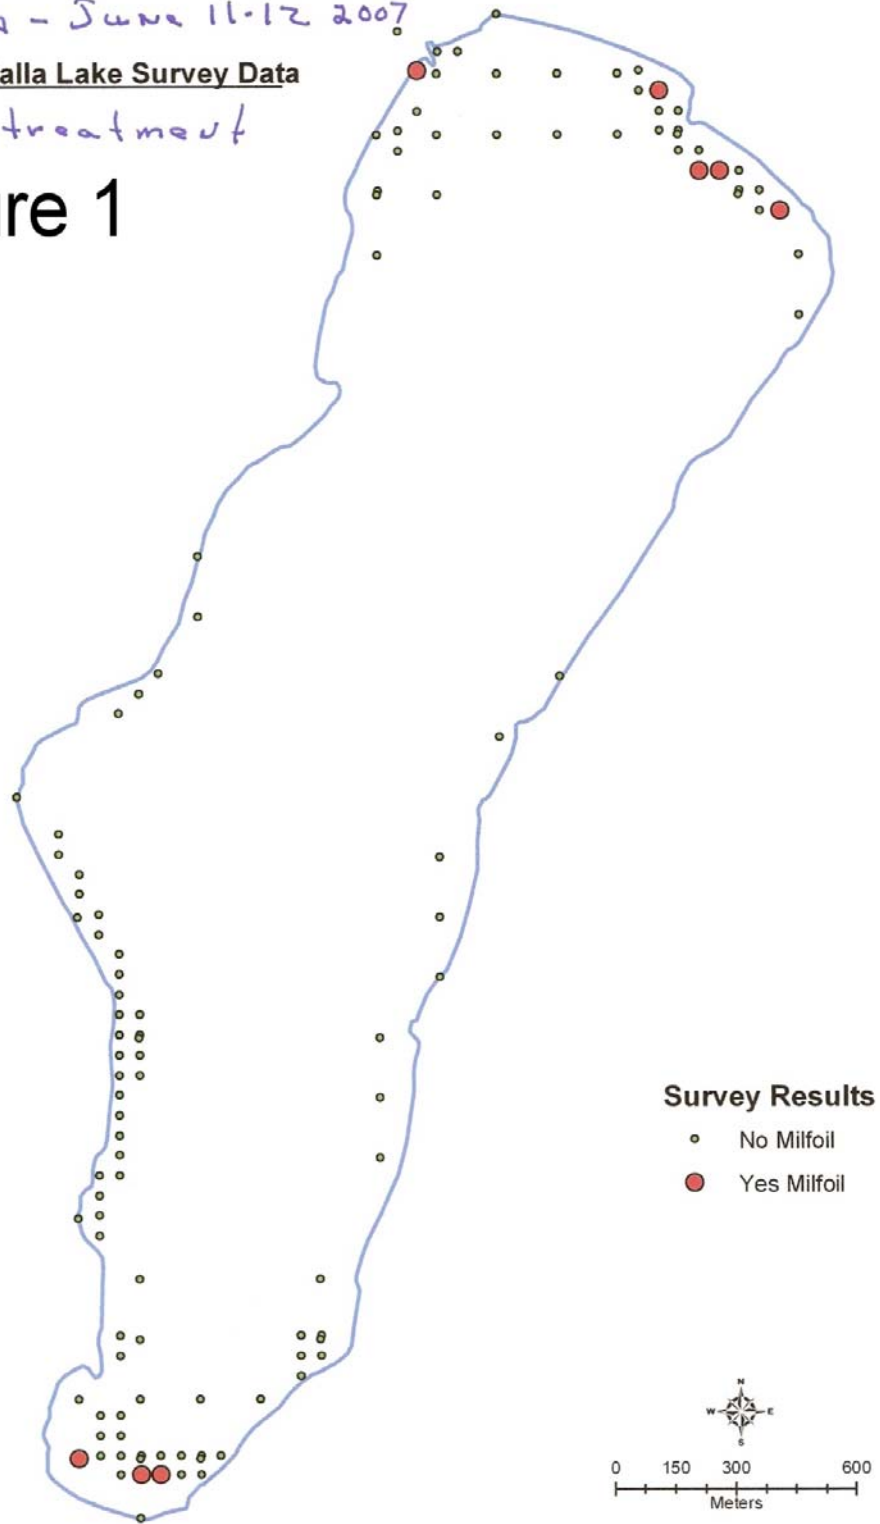
Figure 1

IDA - June 11-12 2007

Cocolalla Lake Survey Data

Pretreatment

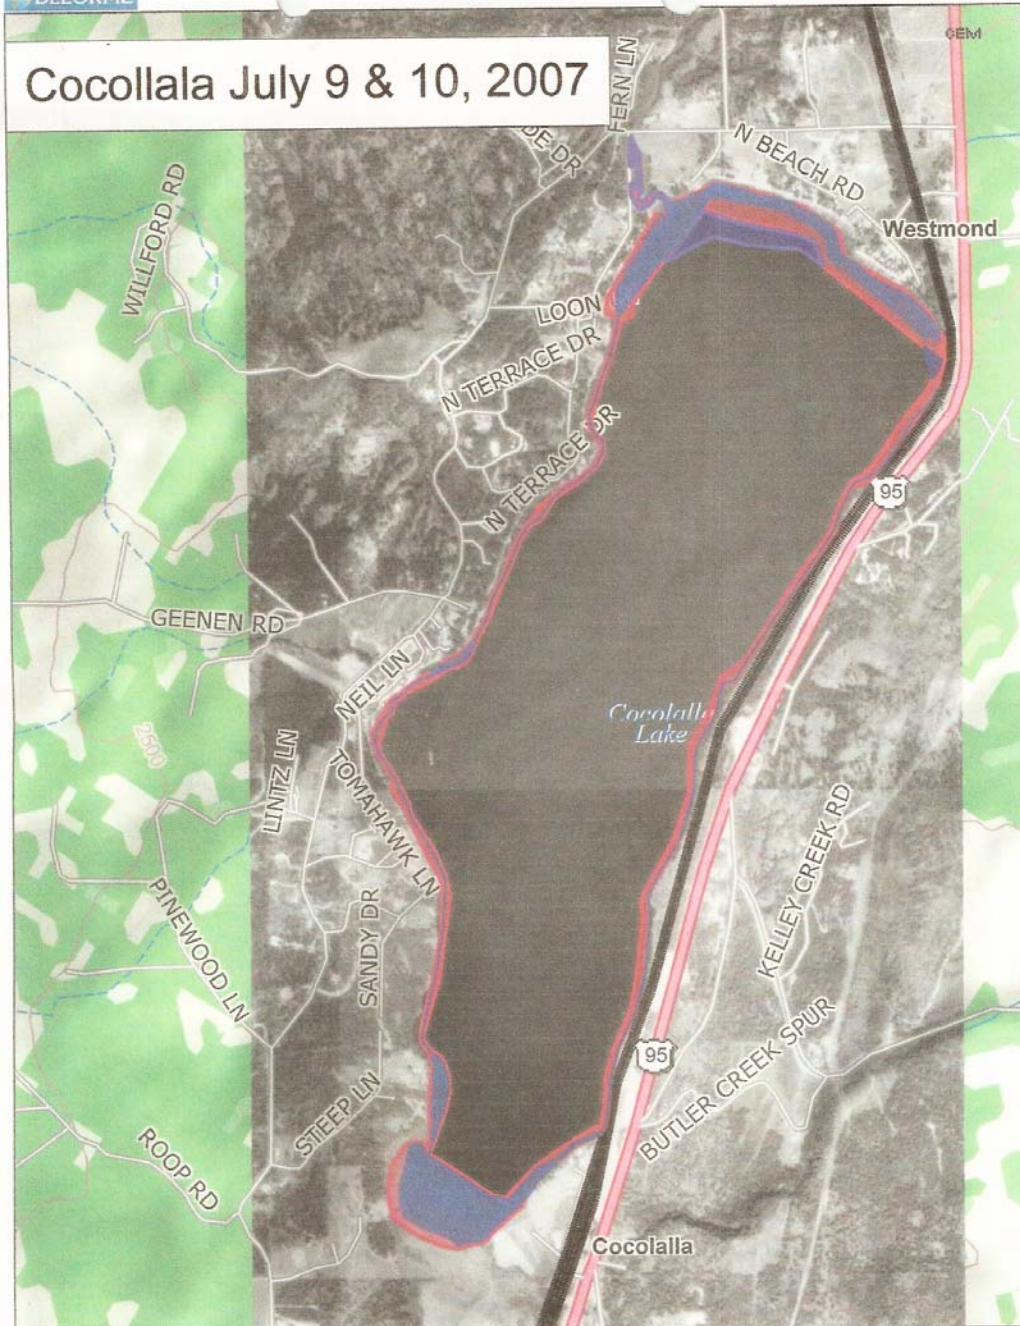
Figure 3

Mapped treatment areas are shown in Figure 3. 90 acres in Cocolalla Lake and the lake outlet stream were treated with DMA 4 IVM (active ingredient 2,4-D) at an application rate of 2.1 gal/acre-ft. Additionally, two acres in the lake outlet stream were treated with Reward (active ingredient diquat) at a rate of 1.5 gal/acre. Post-treatment water chemistry and dissolved oxygen levels are shown in Figures 4 and 5. Sample locations are shown in Figure 6. It is notable that 2,4-D chemical concentration levels remained above 70 ppb until July 29.
