2008 Cocolalla Lake Association Eurasian Watermilfoil Project **Final Report**

Spring 2008 Survey of Cocolalla Lake for Eurasian Watermilfoil Spring 2008 Survey

2008 Survey of Cocolalla Lake for Eurasian Watermilfoil Summer Survey

Fall 2008 Survey of Cocolalla Lake – Final Report

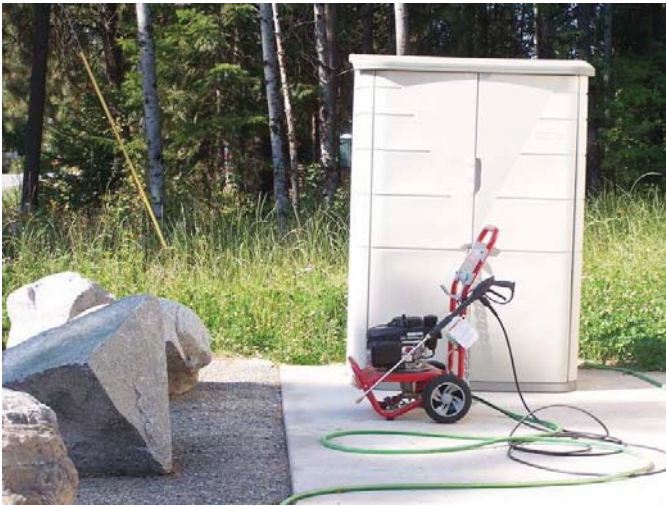
Pressure Washer for Use by Lake Host for Cleaning Watercraft and Trailers

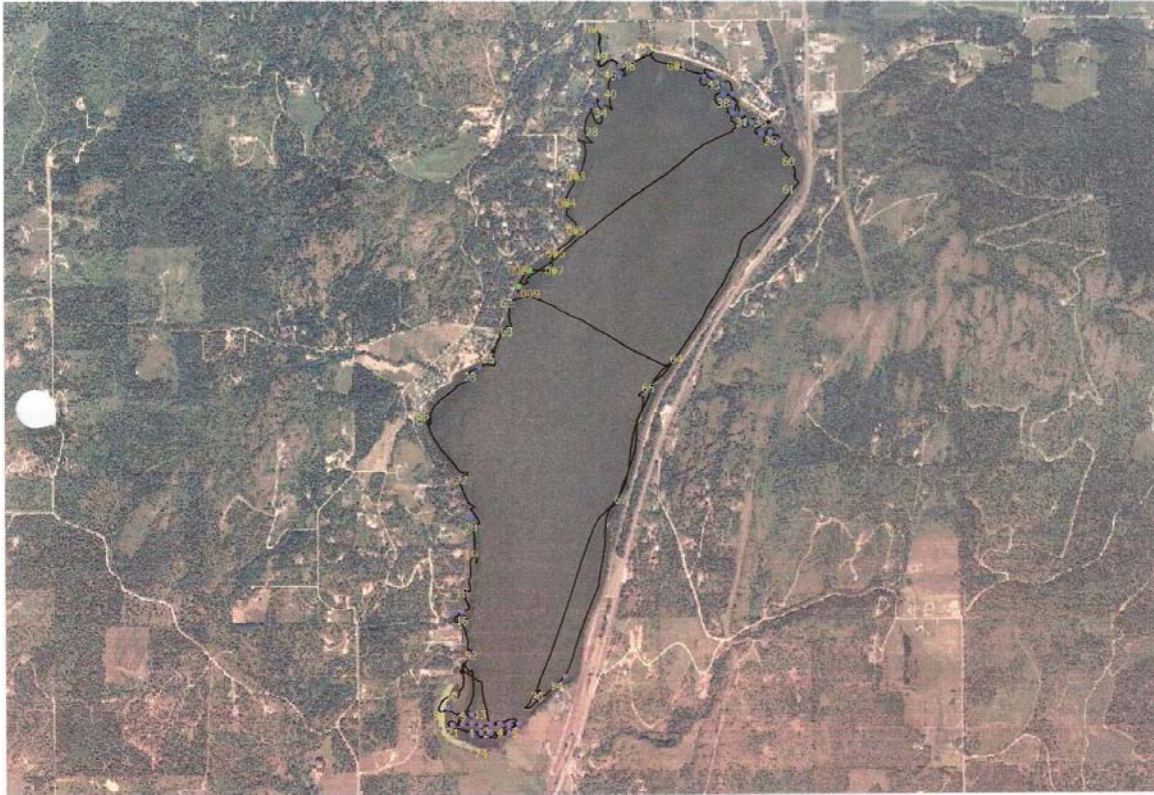
Attachment 1 P 1 of 6

No Eurasian Watermilfoil was located in any of the sample areas.

Lakeland Restoration Services, LLC - Cocolalla Lake - 2008 Spring Eurasian Watermilfoil Survey
